Service Bulletin

Number: 0019

Title: Fuse Correction

Product Identification: PCNC 1100 Milling Machine, serial numbers 1 through 1181.

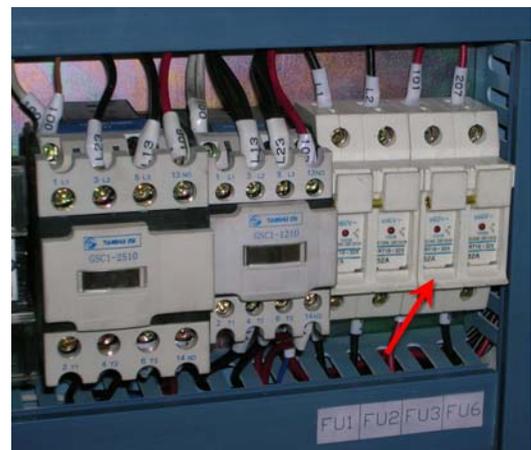
Figure 1 - Location of Fuse FU3

1. Replacement of the fuse. The fuse is in a white receptacle which is mounted on the lower right hand portion of the control panel. The fuse is best identified by the wire numbers that go through it, wires 101 and 102. There may be a fuse identification label below, but this should not be used to identify the proper fuse to replace. Typically the fuse will be the third from the left among a block of 4 fuses as is shown in Figure 1.

Remove the fuse and replace with a 0.6A fuse. The fuse is Tormach PN 30724 but Bussmann KTK-6/10, Littlefuse KLK-.6, or Ferraz ATM-0.6

are appropriate substitutes. Swivel the fuse holder back up to snap the fuse in place and restore machine power.

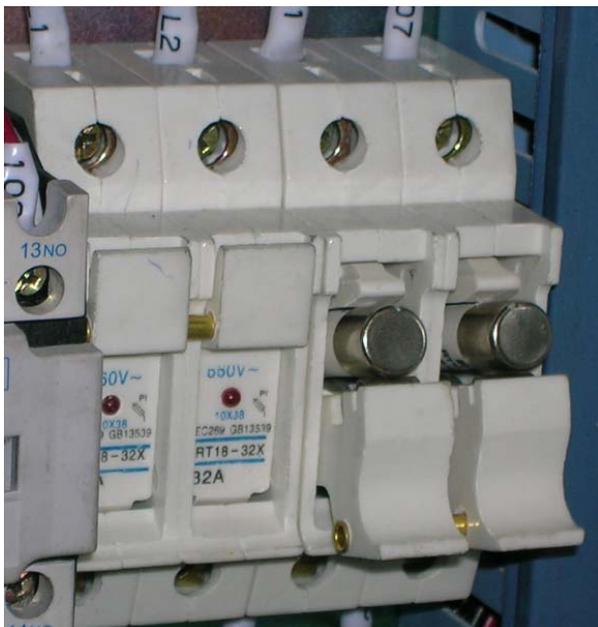
Figure 2 - Fuse block opened

Remove power to the electrical cabinet and then pull down on the upper tab. The fuses are pinned, they will both open as shown in Figure 2.

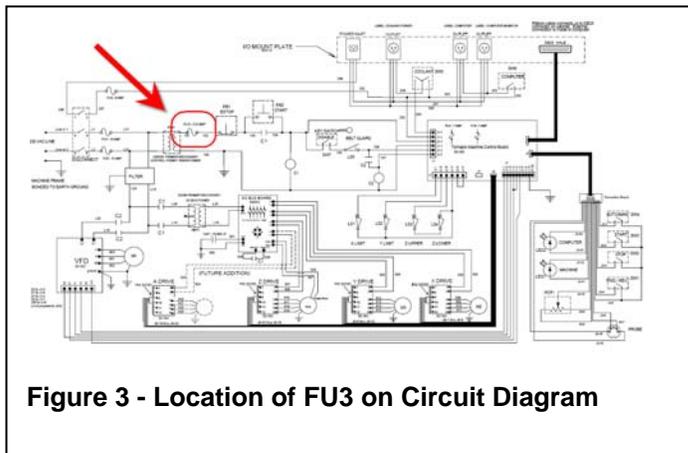
Figure 3 - Location of FU3 on Circuit Diagram

2. Correct the fuse specification in the operator's manual. The electrical parts list and circuit diagram is in section 10 of your owner's manual. Figure 3 shows the location of the fuse specification on the circuit diagram. You can make a notation on the existing circuit diagram or mark out the diagram and insert a revised copy in your manual.
