Service Bulletin

Release Notes for PathPilot™ v1.8.2

Release Date: June 11, 2015

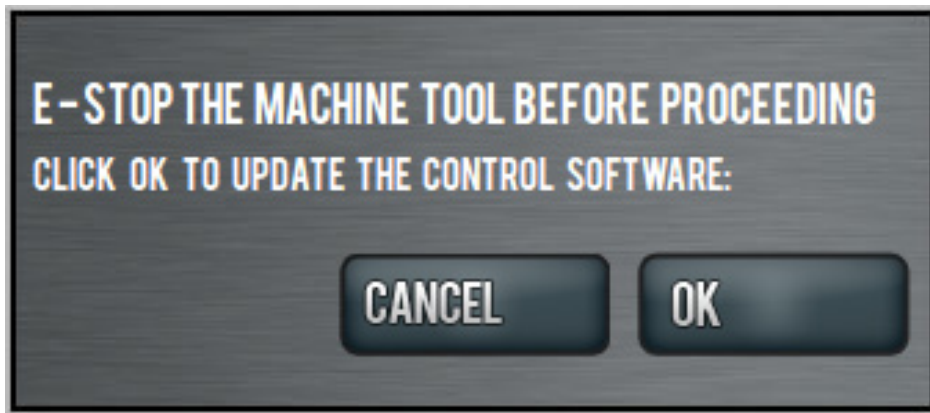
Figure 3

6. Push the E-stop button on the mill when prompted and click OK (see **Figure 3**).
