Release Notes for PathPilot™ v1.9

Release Date: July 10, 2015

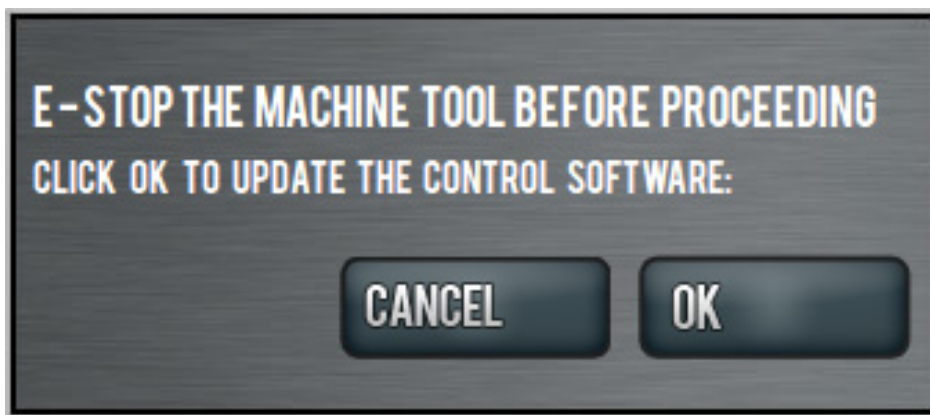
Figure 3

6. Push the E-stop button on the mill when prompted and click OK (see **Figure 3**).
